INDOOR AIR QUALITY ASSESSMENT

**Bryantville Elementary School
29 Gurney Drive
Pembroke, MA**

Prepared by:
Massachusetts Department of Public Health
Bureau of Environmental Health
Indoor Air Quality Program
October 2017

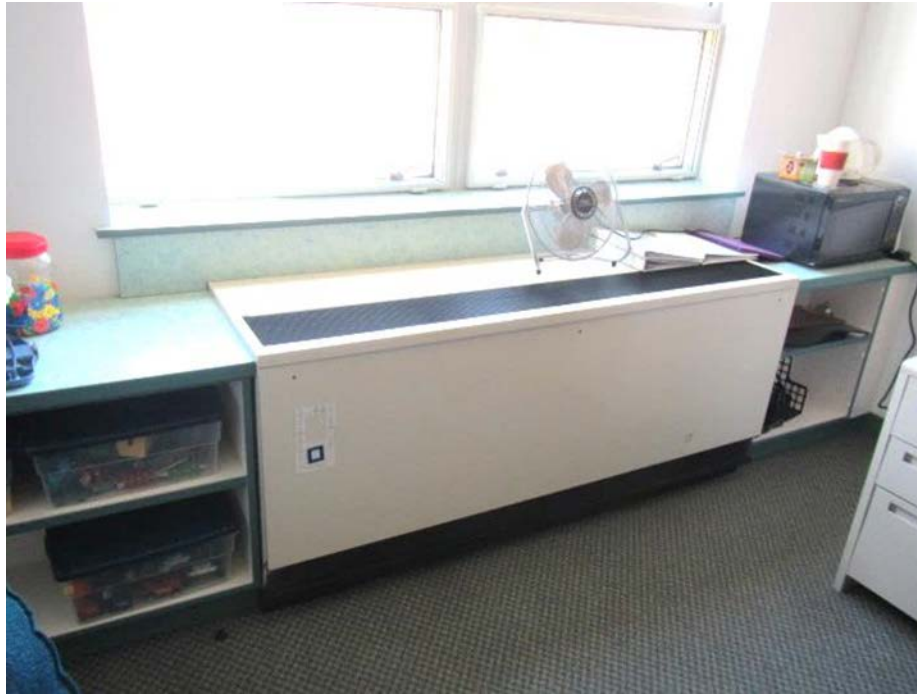
Picture 1

Fresh air is provided by a combination of unit ventilators (univents) located in individual classrooms (Picture 1) and air handling units (AHUs; Picture 2), which serve central areas such as the gym, library and office areas. The unit ventilators draw fresh air through a vent on the exterior wall (Picture 3). Air is mixed with return air from the room, filtered, heated (if needed) and delivered to the room ([Figure 1](#)). Air from the AHUs is filtered, heated or cooled as needed, and delivered to rooms via ducted supply vents (Picture 4).

Classroom unit

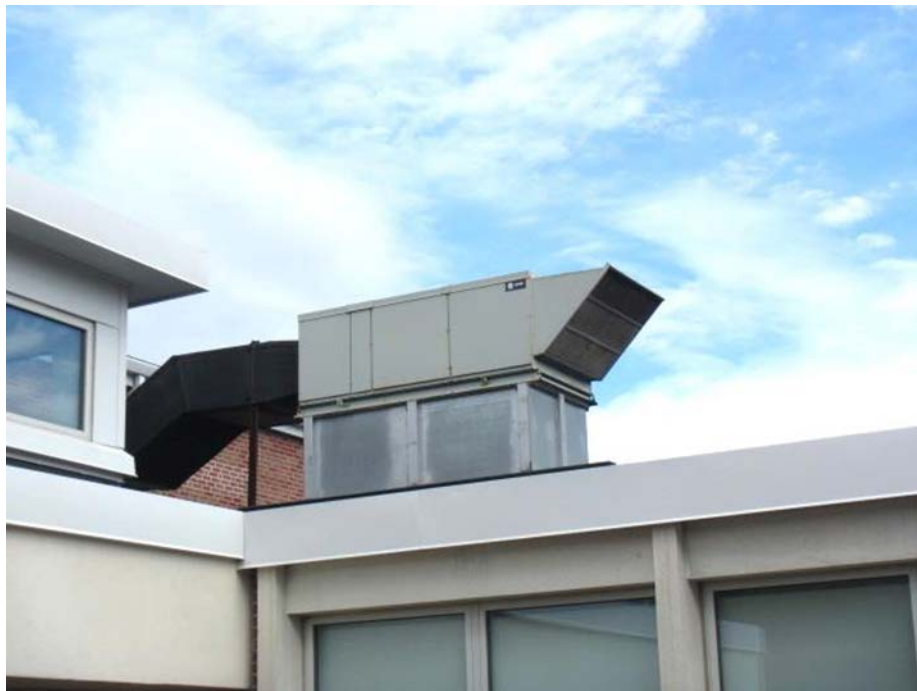
Picture 2

Rooftop air handling unit

16. Continue to change filters for HVAC equipment 2-4 times a year. The MDPH recommends using pleated filters of Minimum Efficiency Reporting Value (MERV) of 8, which are adequate in filtering out pollen and mold spores (ASHRAE, 2012), if these can be used with current equipment.

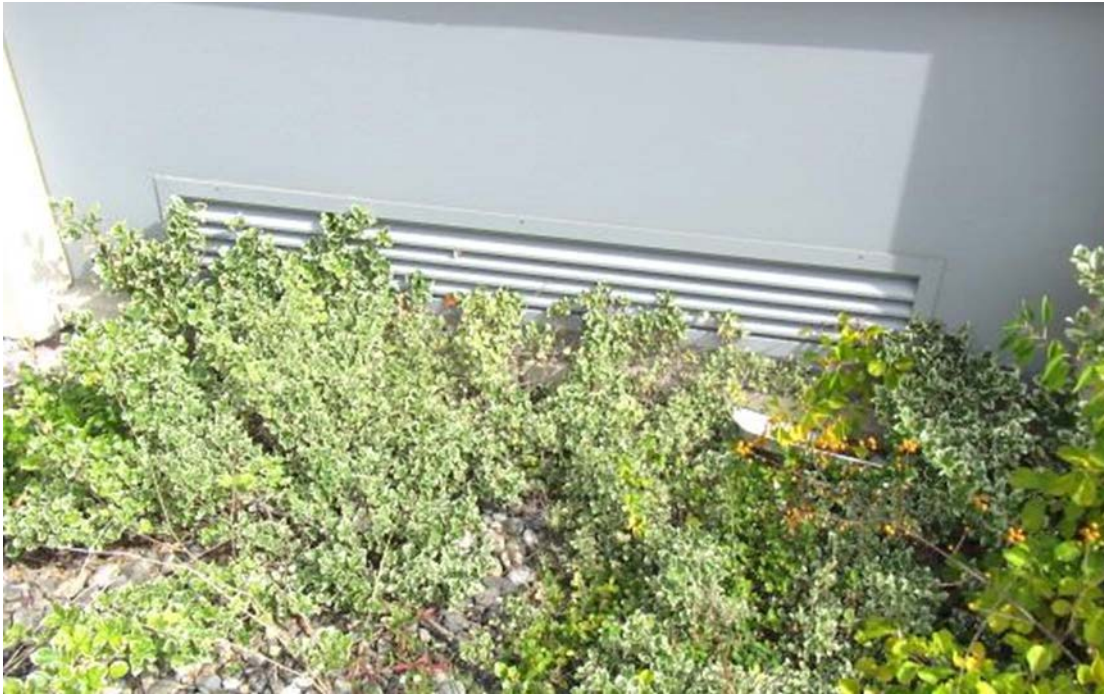
Picture 3

Univent fresh air intake, note plants/shrubbery

8. Ensure roof and plumbing leaks are repaired and replace water-damaged ceiling tiles.
9. Ensure plants, trees and shrubs are located at least five feet away from exterior walls/foundation of the building in both courtyards and around the exterior of the building.

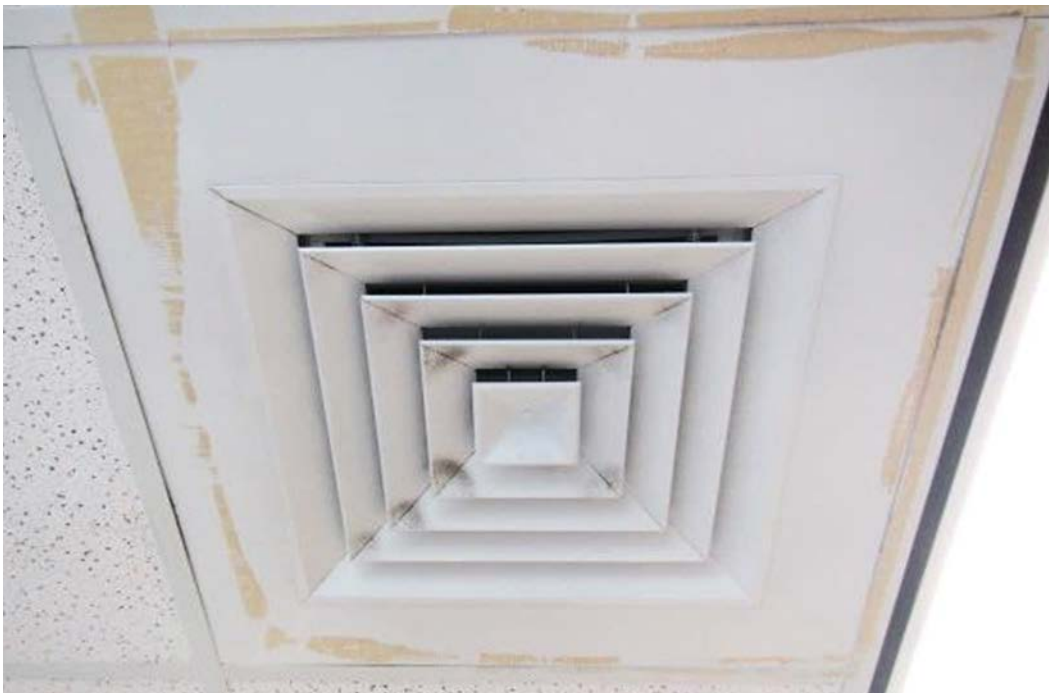
Picture 4

Many classrooms had personal fans. Some of these had dusty blades (Picture 16; Table 1). Some supply diffusers (Picture 4) and exhaust vents were also observed to be dusty. This dust can be reaerosolized when the equipment is activated. In many areas, items, including books, papers, toys and decorative items were observed on floors, windowsills, tabletops, counters, bookcases, and desks (Picture 17; Table 1), which can make it more difficult for custodial staff to clean.

Ceiling-mounted supply diffuser, note dust/debris on louvers

17. Regularly clean/vacuum univent cabinets, supply/return vents and fans to avoid aerosolizing accumulated particulate matter. Consider using compressed air to loosen/remove accumulated dust/debris in hard to access univent grills/cabinets, and then vacuum with a HEPA vacuum cleaner.

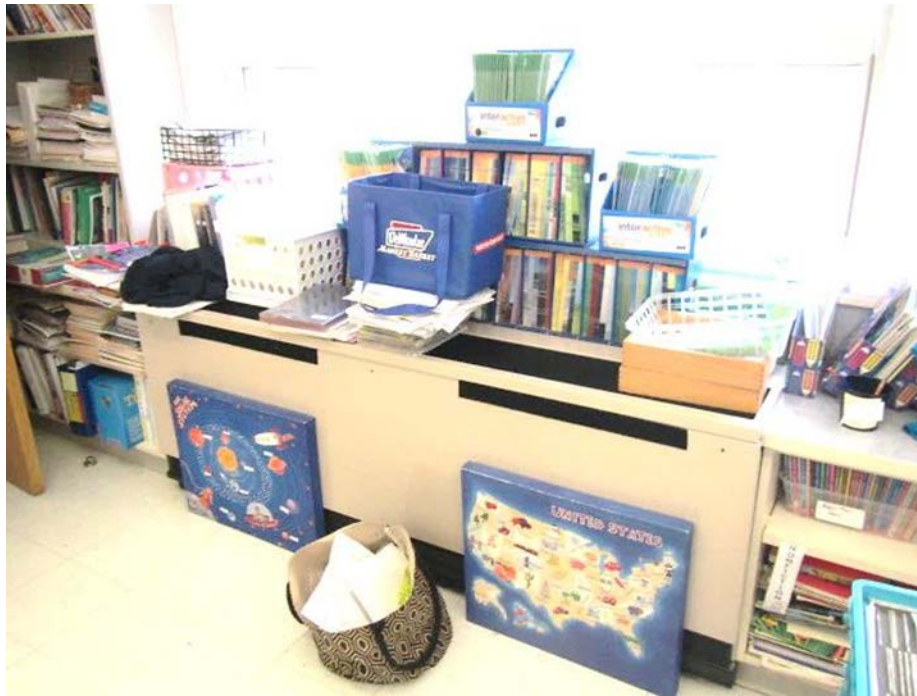
Picture 5

It was reported that univents operate under an automated/energy efficiency management system and cycle off/on according to the set point of the thermostat, which deactivates the HVAC system when it reaches a preset temperature, therefore, no mechanical ventilation is provided until the thermostat reactivates the system. To maximize air exchange, the MDPH recommends that both supply and exhaust ventilation operate *continuously* during periods of occupancy. In addition, many univents were obstructed by items placed on top or in front (Pictures 5 and 6). Both the top and the vent at the bottom need to be kept clear of obstructions for the units to operate as designed.

Items on univent/front of return vent (bottom/front)

3. Remove items and furniture blocking univents both on top and along the front.
4. Check exhaust vents for draw periodically and repair any non-operating vents.

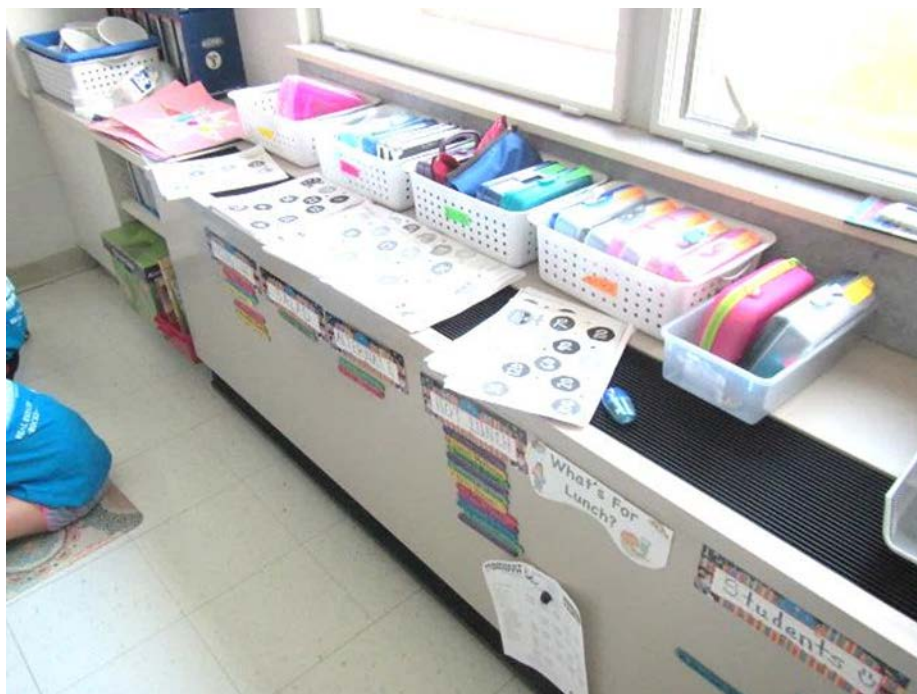
Picture 6

Items on top of univent air diffuser

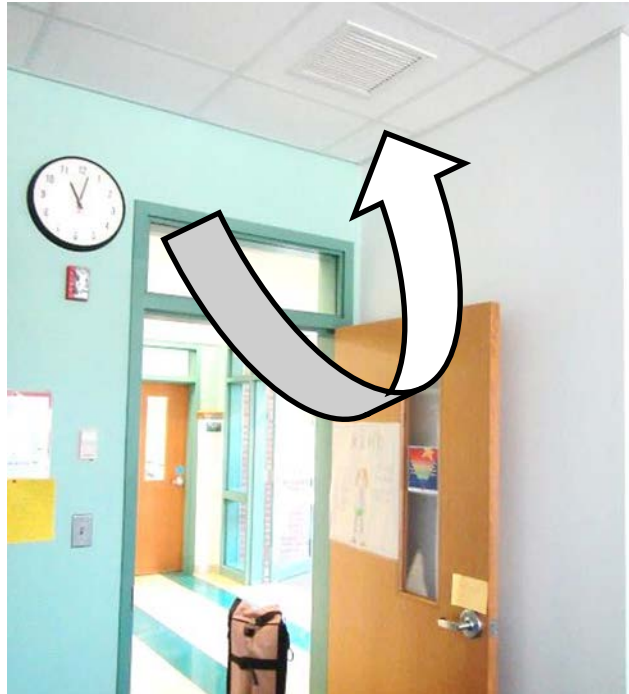
Picture 7

Air is exhausted from ceiling-mounted exhaust vents on the opposite side of the room, in some cases near classroom doors (Picture 7). Note that when classroom doors are open, exhaust vents will tend to pull hallway air into the classroom instead of removing stale air/pollutants from the room and out the building.

Ceiling-mounted exhaust vent near open classroom door

5. Close classroom doors to facilitate exhaust function.
6. Consider adopting a balancing schedule of every 5 years for all mechanical ventilation systems, as recommended by ventilation industrial standards (SMACNA, 1994).

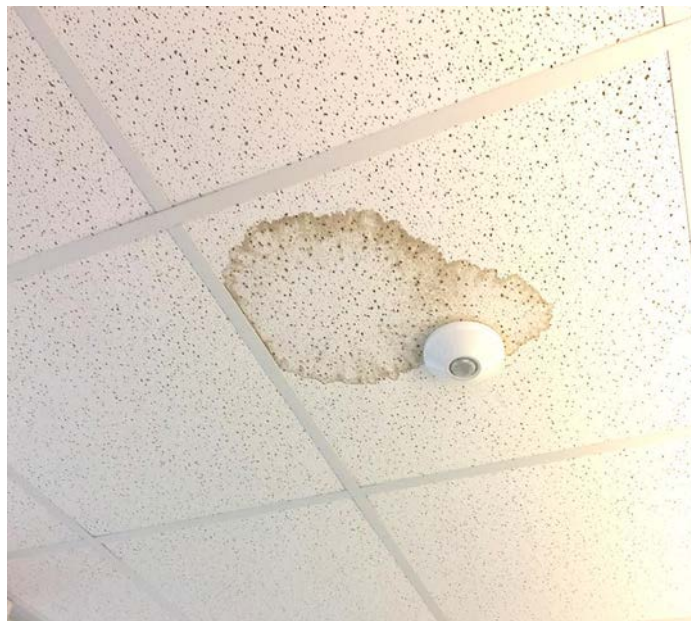
Picture 8

Water-damaged ceiling tiles were observed in a few areas (Picture 8; Table 1), which indicate leaks from the building envelope or plumbing system. These tiles should be replaced after the leak is found and repaired. It was reported that roof repairs had recently been conducted to prevent further leaks.

Water-damaged ceiling tile

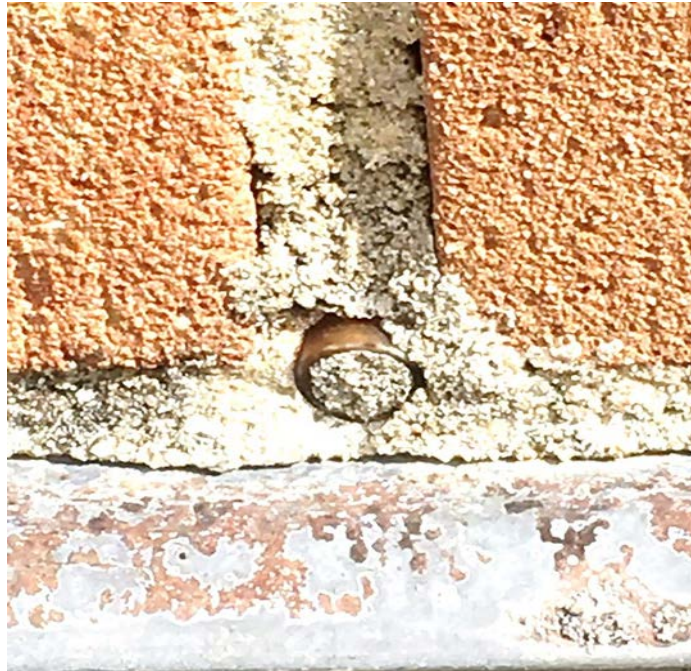
Picture 9

The exterior of the BES consists of a traditional red brick exterior wall. An examination of brick walls was conducted (along the exterior and in courtyards) to identify the location and condition of weep holes. Weep holes were found approximately at the slab level. Of note is that many weep holes were blocked with debris (Picture 9) or buried, which prevents water drainage from the exterior wall system.

Blocked weep hole

10. Remove blockages from all weep holes and clear obstructions to walls to maximize water drainage from exterior wall systems.
11. Properly maintain plants, including drip pans, to prevent water damage to porous materials. Plants should also be located away from air diffusers to prevent the aerosolization of dirt, pollen, and mold.

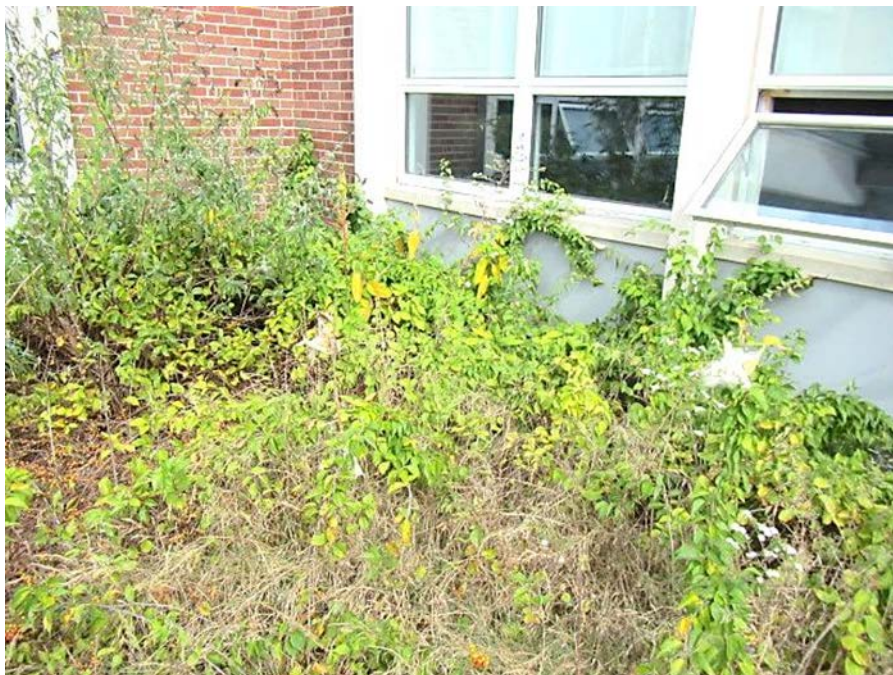
Picture 10

The school is built around four courtyards which are severely overgrown with trees, shrubbery and other plants (Pictures 10 and 11). Trees were also observed overhanging the roof in some areas (Picture 12). These conditions can lead to deterioration of the building envelope due to root infiltration and dampness against exterior walls/foundation. Plants can also be a source of moisture, debris and pollen drawn into air intakes. Plants/trees should be trimmed away from the building and from overhanging the roof to prevent clogging of roof drains/gutters.

Courtyard overgrown with plants/shrubbery

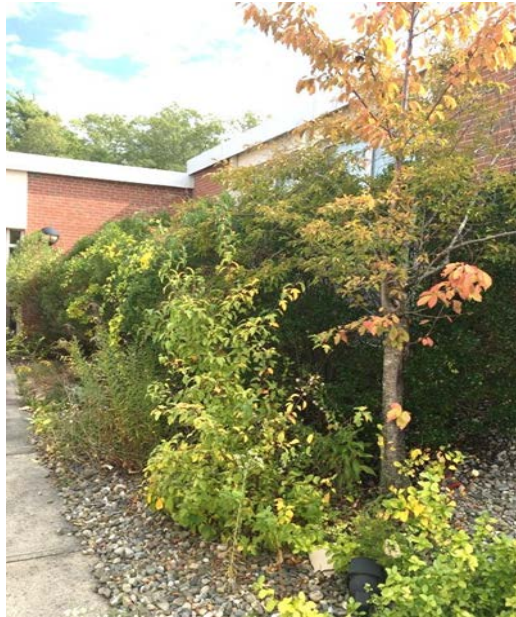
Picture 11

Courtyard overgrown with trees, plants and shrubbery

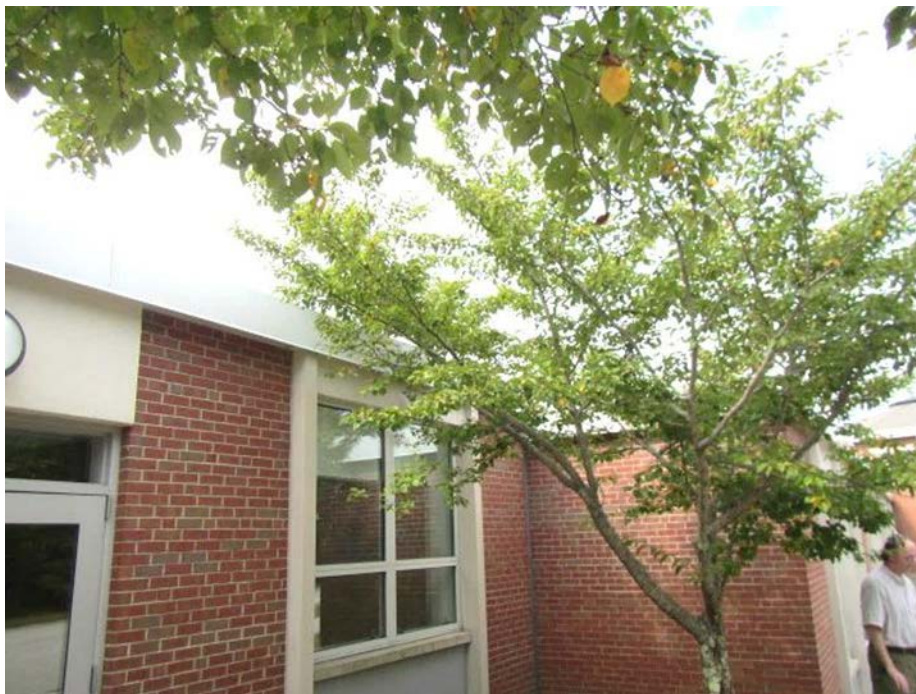
Picture 12

Trees overhanging roof

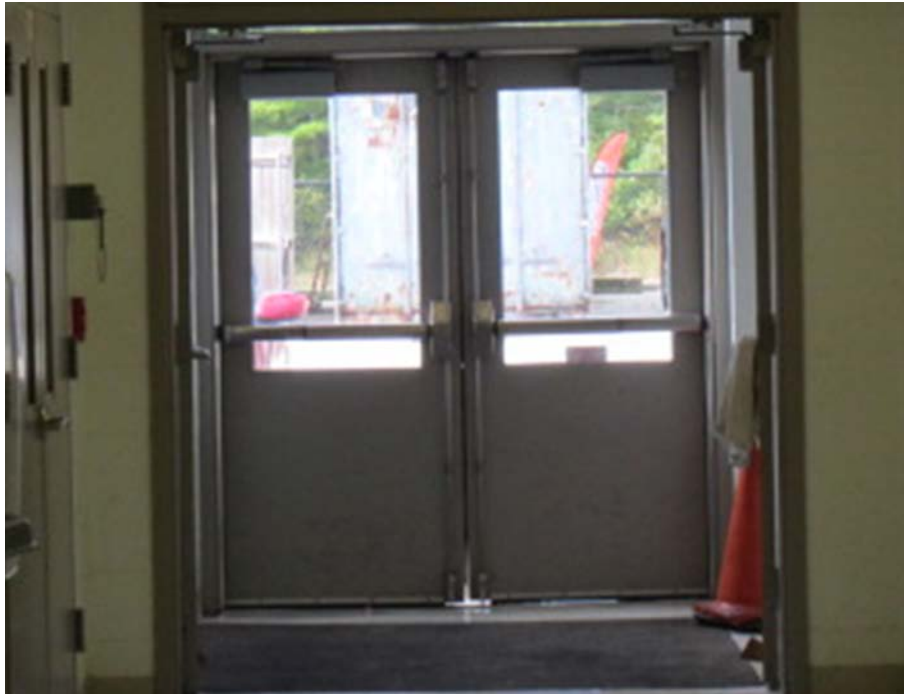
Picture 13

Light could be seen beneath the exterior door to entrance #3 (Picture 13). The exterior was examined and found to have a missing/damaged door sweep (Picture 14), which can provide a pathway for moisture, drafts and or pests into the building.

Light penetrating beneath doorway #3

12. Replace missing/damaged sweeps on exterior doors. Ensure tightness by monitoring for light penetration around doors.
13. Reduce use of products and equipment that create VOCs; only use in well-ventilated areas.

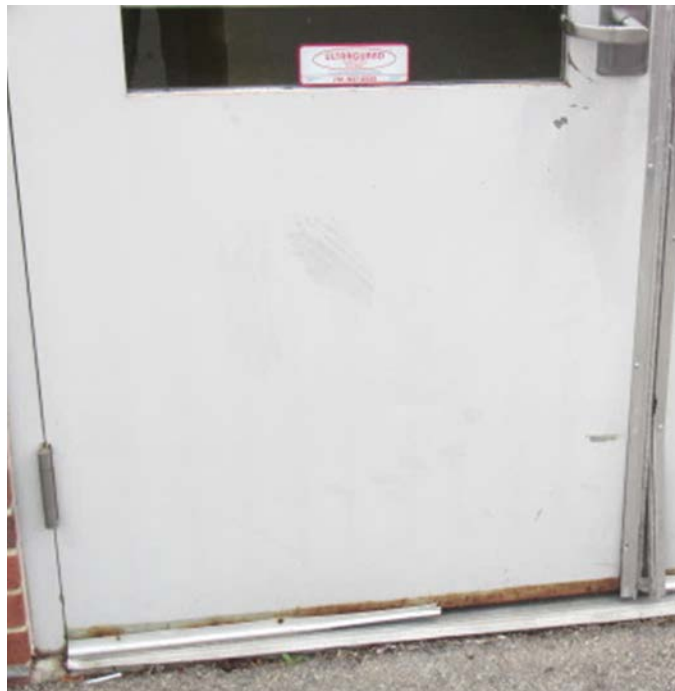
Picture 14

Missing/damaged door sweep

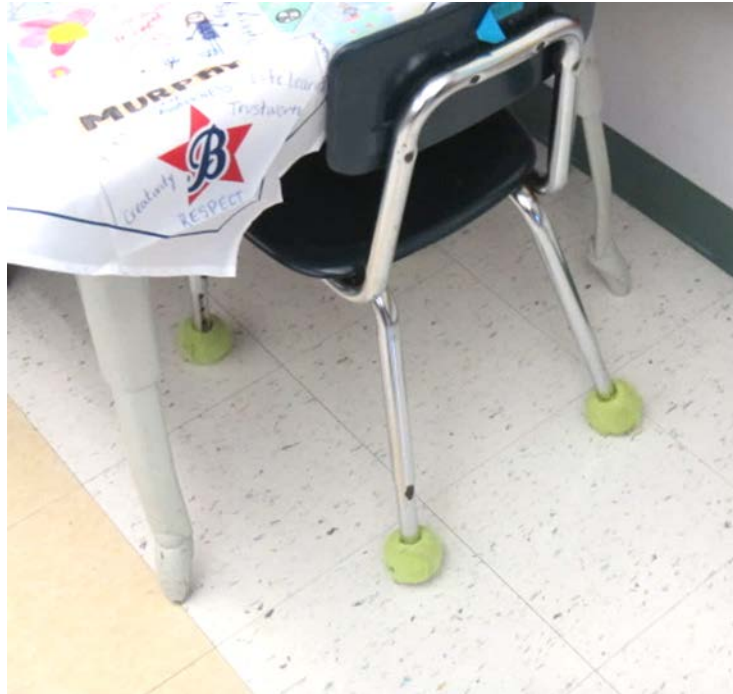
Picture 15

In a few areas, tennis balls had been sliced open and placed on chair footings to reduce noise (Picture 15). Tennis balls are made of a number of materials that are a source of respiratory irritants. Constant wearing of tennis balls can produce fibers and lead to off-gassing of VOCs. Tennis balls are made with a natural rubber latex bladder, which becomes abraded when used as a chair leg pad. Use of tennis balls in this manner may introduce latex dust into the school environment. Some individuals are highly allergic to latex (e.g., spina bifida patients) (SBAA, 2001). It is recommended that the use of materials containing latex be limited in buildings to reduce the likelihood of symptoms in sensitive individuals (NIOSH, 1997; NIOSH, 1998).

Tennis balls on chair legs

14. Keep spray bottles/cleaning products out of the reach of children (e.g., in cabinets over sinks).
15. Replace tennis balls on chair footings with latex-free glides.

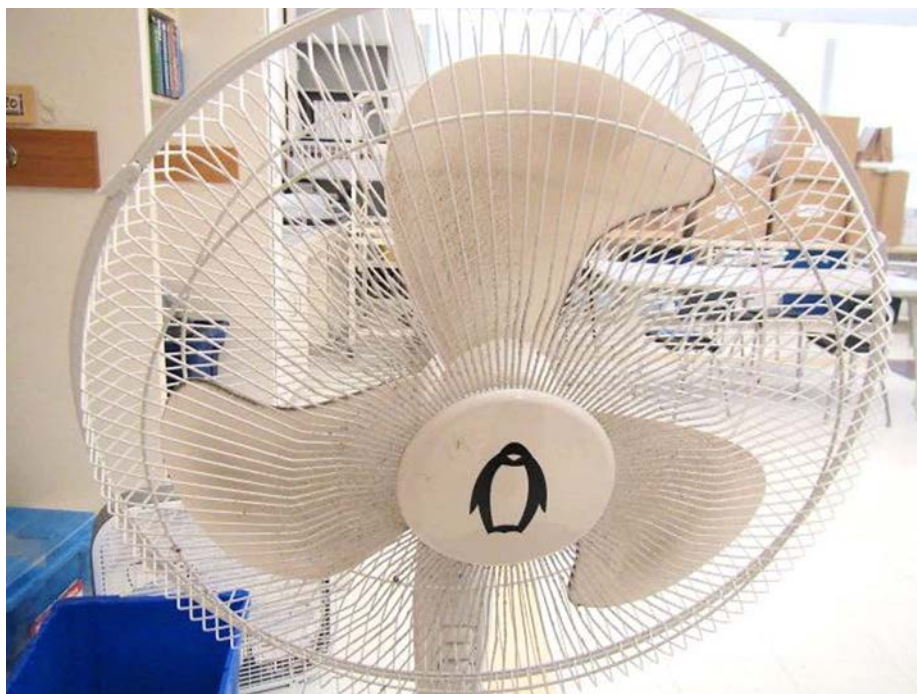
Picture 16

Accumulated dust/debris on fan blades

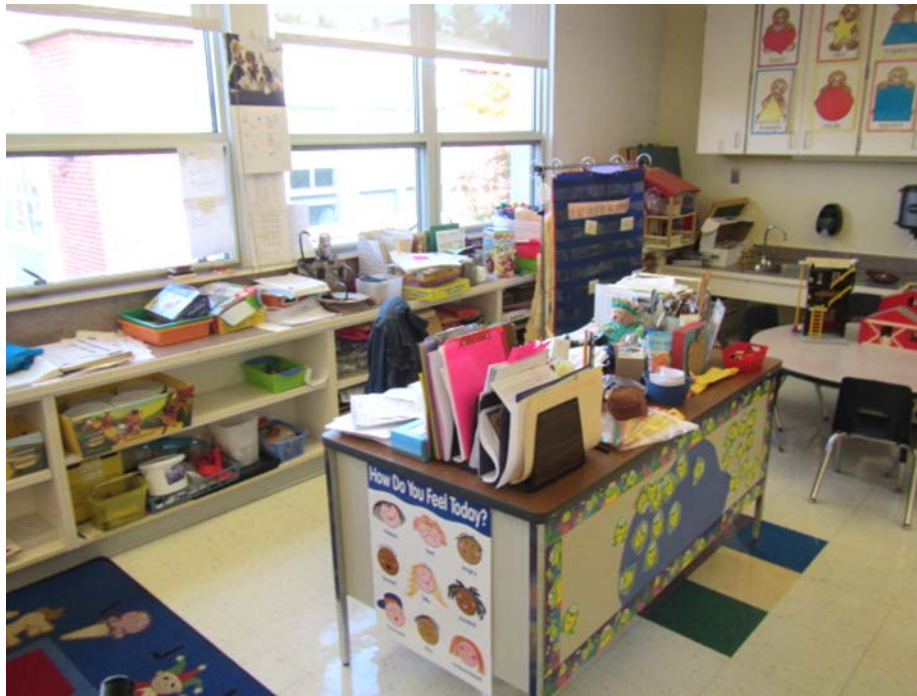
Picture 17

Accumulated items on flat surfaces

18. Clean window-mounted air conditioner filters prior to the start of the cooling season and according to the manufacturer's instructions.
19. Consider reducing the amount of items stored in classrooms to make cleaning easier. Periodically move items to clean flat surfaces.
